We have a unique opportunity to support a local mission project. The Mision Metodista Hispana de Soledad, (Soledad UMC), parsonage in the South San Jose District is in dire need of repairs.

UMC Parsonage at 300 Major Street, Soledad

The Situation

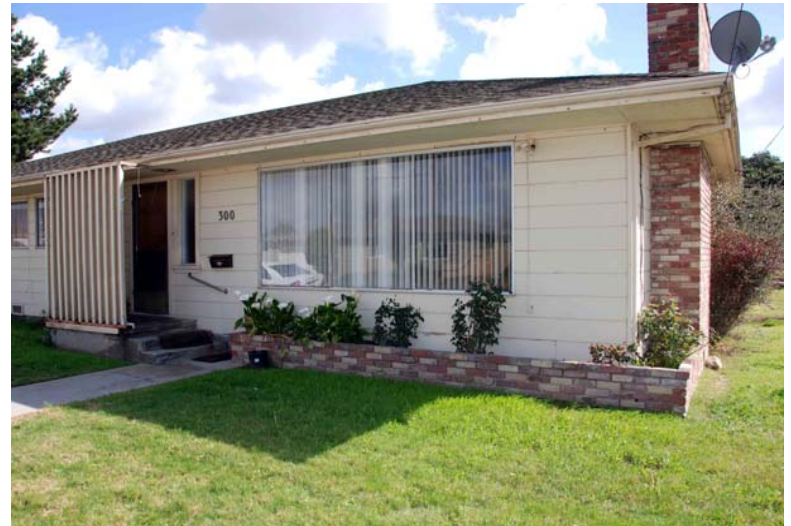
The insides of most windows are visibly wet from condensation. The original single pane windows show evidence of prior mold and fungus growth that appears to be continually removed. At least the large living room window (shown in house photo) should be replaced with two or three double pane windows that can be opened for ventilation.

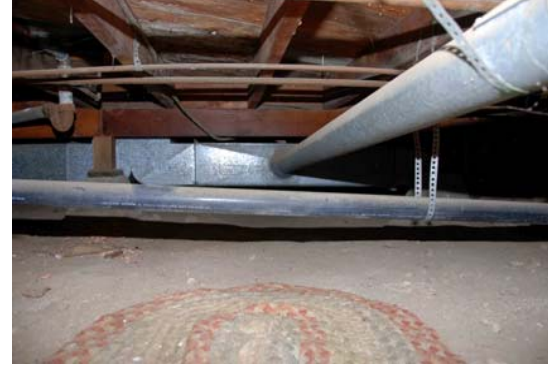
The heating ducts under the house are not insulated. Two rooms do not get any heat! This sheet metal ductwork needs to be replaced with insulated ducting to provide adequate heat for the house.

Un-insulated
heater ducting
under house

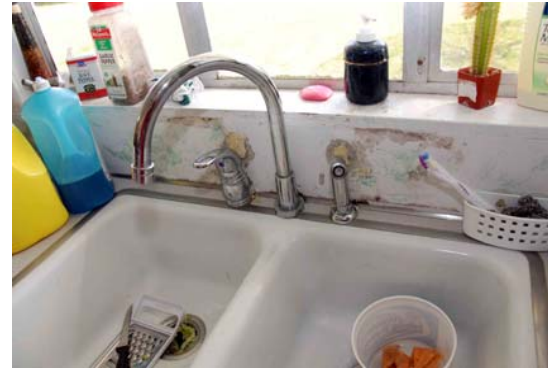
The plumbing is old and in many cases has been altered to make repairs. Bathroom fixtures need replacement. The hall bath had a shower installed without adequate provision for walls being sprayed by water. There is a drainage problem in the bathrooms, and under-sink piping is suspect under the hall bath. Inadequate venting has created a moisture problem from condensation in both bathrooms. The kitchen sink fixture is worn out and holes remain in the splashboards from prior repairs in the kitchen and laundry area.

Need plumbing
repairs in kitchen,
bathtub / shower

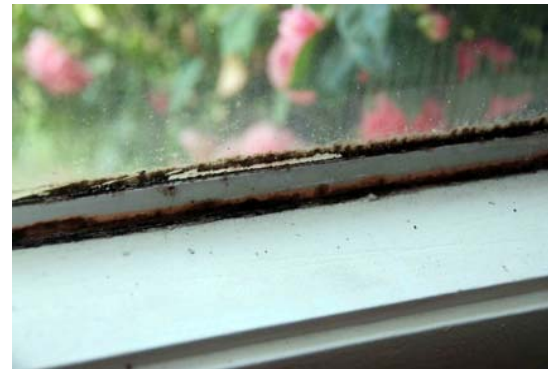
Need double
pane windows
in living room

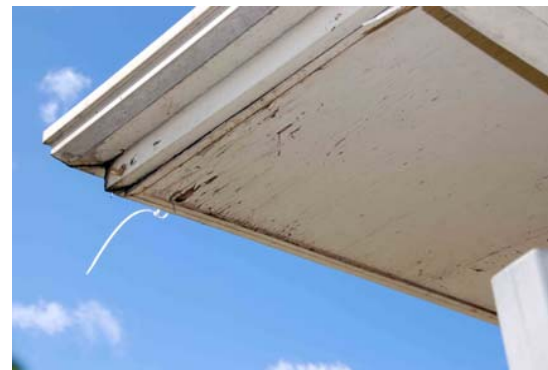
Water
penetration
in eaves
